# Monitoring the Natural Heating of Two Art Nouveau Glass Windows by Infrared Thermography

*This manuscript presents the results of monitoring the natural thermal variations of two Art Nouveau glass windows from the Casa-Museu Dr. Anastácio Gonçalves in Lisbon, Portugal, by active infrared thermography. The temperature of the glass was found to relate to the environmental temperature and, mainly, to the impinging direct solar radiation. The latter induced an increase in temperature up to 10 °C within one hour, which can produce thermal shock. After sunset, the cooling was also very fast. The increase in temperature also depends on the glass chromophores and the presence of enamel or grisaille. Regarding the effect of external protective glazing, insufficient air ventilation was found to favour the accumulation of warm air in the upper parts of the panels, which could damage the stained-glass windows in the long term.*

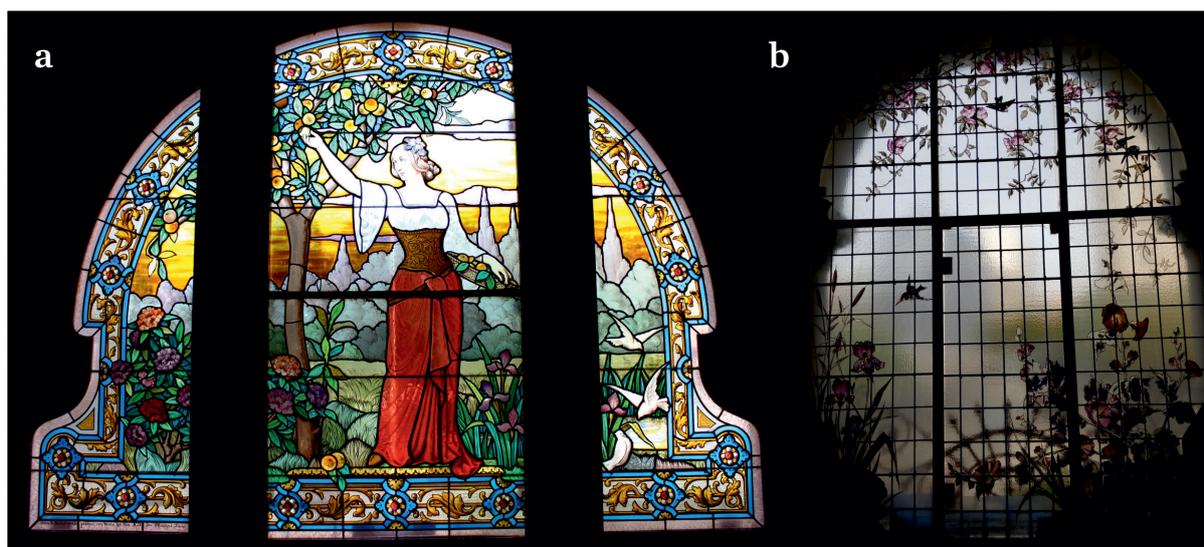
**Figure 1.** a) Dining room window. *Société Artistique de Peinture sur Verre*, 1904 CE, stained-glass window with three lights: H 188 cm × W 64 cm, H 210 cm × W 98 cm, and H 188 cm × W 64 cm; b) Atelier window. *Société Artistique de Peinture sur Verre*, 1904 CE, stained-glass window, H 260 cm × W 196 cm.

The *Casa-Museu Dr. Anastácio Gonçalves* in Lisbon has two glass windows in Art Nouveau style signed by the *Société Artistique de Peinture sur Verre*, 1904. One is located on the first floor in the Dining room (Figure 1a), and the other is in the Atelier on the second floor (Figure 1b). The latter panel is in a poor state of preservation with loss of the blue and purple enamels and has probably been retouched. Its left and upper panels, as viewed from inside the building, are shadowed by the architectural features. Both windows have exterior protective single-glazing. They are frameless glazing systems that permit the opening of both the glazings and the stained-glass windows. Ventilation slits, measuring less than 5 mm in some areas, separate the different protective glazings and the protective glass from the wall.

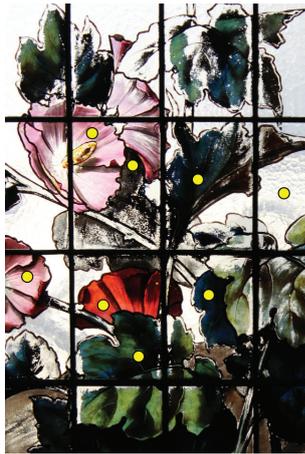
**Figure 4.** Detail of the Atelier window, and the thermal variation of different points marked with yellow circles; sample areas average temperature over 2.5 cm<sup>2</sup>

Point analysis on different enamels from the Atelier window confirmed that thermal behaviour depends on the colour of the enamel (Figure 4). The colourless glass had the lowest temperature with direct solar radiation, followed by light-coloured enamels, such as the pale pink. Red, bluish-green, and blue enamels had higher

temperatures with direct solar radiation; and, darker enamels, such as brown and dark blue, showed the highest temperatures (Figure 4). These latter materials were dark vitreous paints, some of them from a previous restoration, with iron oxides in their composition, fostering intense absorption of the thermal radiation and, resultantly, increasing the apparent surface temperature (Palomar et al. 2018a). It should be noted that the temperature variation between colourless and dark brown is about three degrees Celsius. This increase in the darker layers favours a higher thermal expansion of the surface layer in comparison with the support glass, which could cause fissures and detachments.
